RESERVOIRS

FOR IRRIGATION, WATER-POWER

DOMESTIC WATER-SUPPLY

WITH AN ACCOUNT OF VARIOUS TYPES OF DAMS AND THE
METHODS, PLANS AND COST OF THEIR CONSTRUCTION

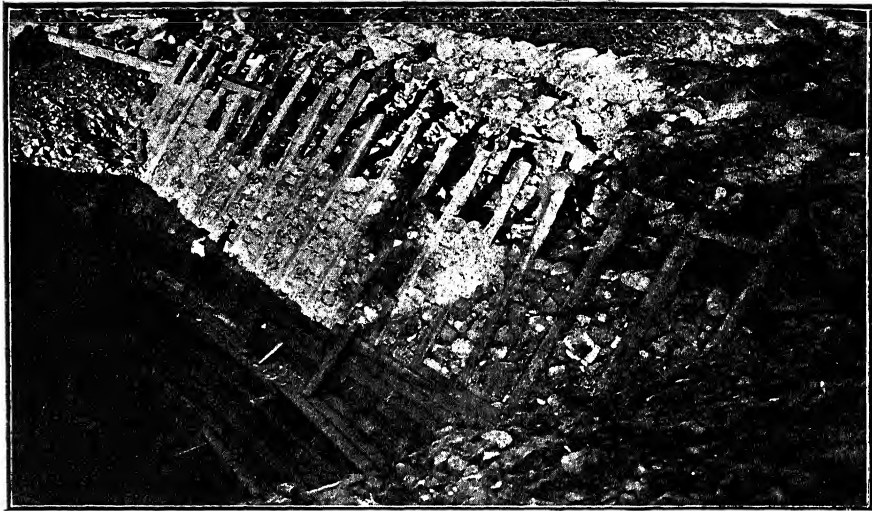
Inclined posts, placed at an angle of 45° , are first set up and held in position by struts that are subsequently removed. These posts are long enough to reach from bed-rock to the crest of the dam. The rock-fill is carefully laid by hand between the posts, forming a face flush with the exterior face of the posts. They are spaced 4 feet apart, center to center. At intervals of 6 feet, from bottom to top, an iron rod, $\frac{3}{4}$ of an inch in diameter, passes through each of the posts to an anchorage back in the rock-fill. This anchorage is made by winding the rods around the largest stones that are selected for that purpose. These posts are of varying size, but the smallest are 9 inches across at top.

The plank face is made with but one layer of well-seasoned $3'' \times 8''$ pine plank, laid horizontally, and driven tightly together. The bottom

FIG. 345.—THE WEAVER LAKE DAM, CALIFORNIA, SHOWING RECENT CONSTRUCTION.

edge of each plank is cut with a caulking bevel of one-half inch in the thickness of 3 inches, but no caulking is done by hand, reliance being placed upon the sediment and floating organic matter in the water to make the joints tight. The planks are held by two 6-inch spikes at each post.

The Weaver Lake Dam.—A new dam has recently been constructed at Weaver lake, within a mile of Bowman dam, which is typical of the class of rock-fill wood-faced dams. The method of construction is well shown by the photograph, Fig. 345.

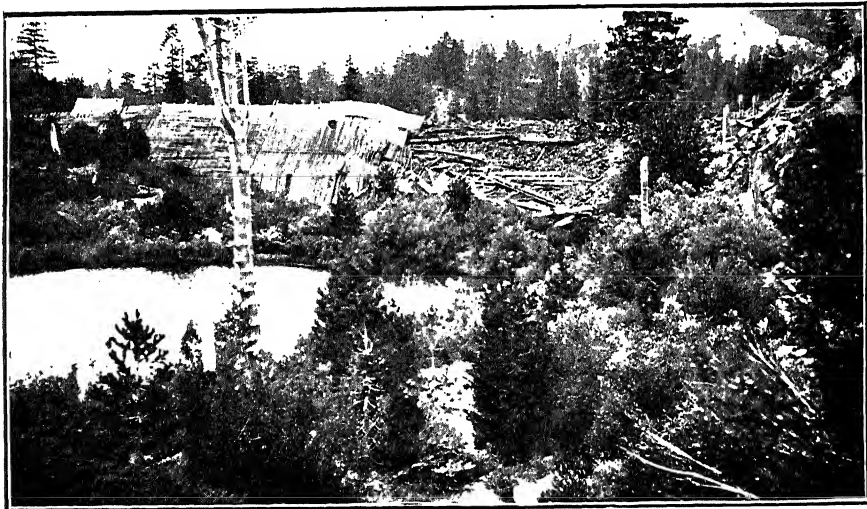
FIG. 347.—GENERAL VIEW OF THE TIMBER SKIN ON UP-STREAM SIDE OF THE ENGLISH LAKE DAM. NOW IN RUIN.

The existing dams both have a crest extension of wood, 6 feet high, of similar construction. (See Figs. 346 and 347.) This is also well illustrated by Fig. 348, showing the dry wall laid up on the down-stream face.

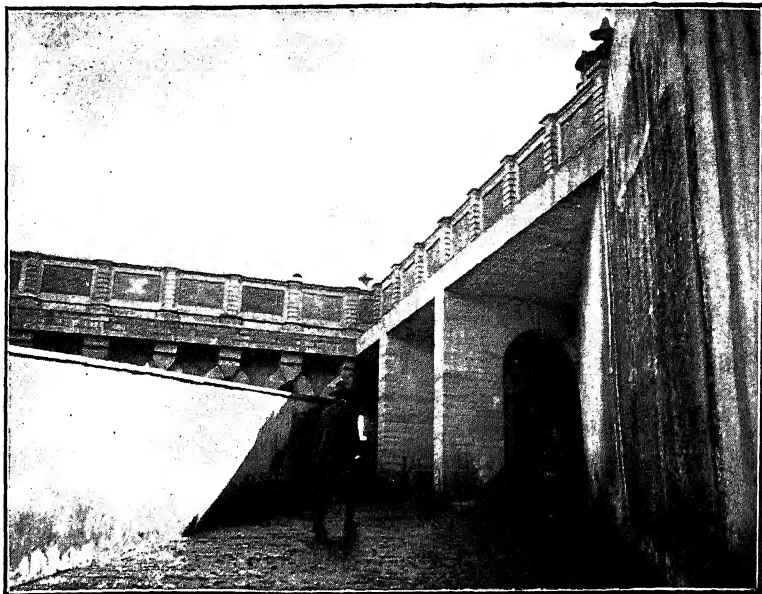
FIG. 365.—THE SPILLWAY CHANNEL OF THE ESPERANZA DAM, AT ITS UPPER END, SHOWING OBSTRUCTIONS TO FREE DISCHARGE BY PIERS SUPPORTING ROADWAY.

somewhat obstructed by the masonry piers supporting the roadway on the top of the dam, as seen in Fig. 365.

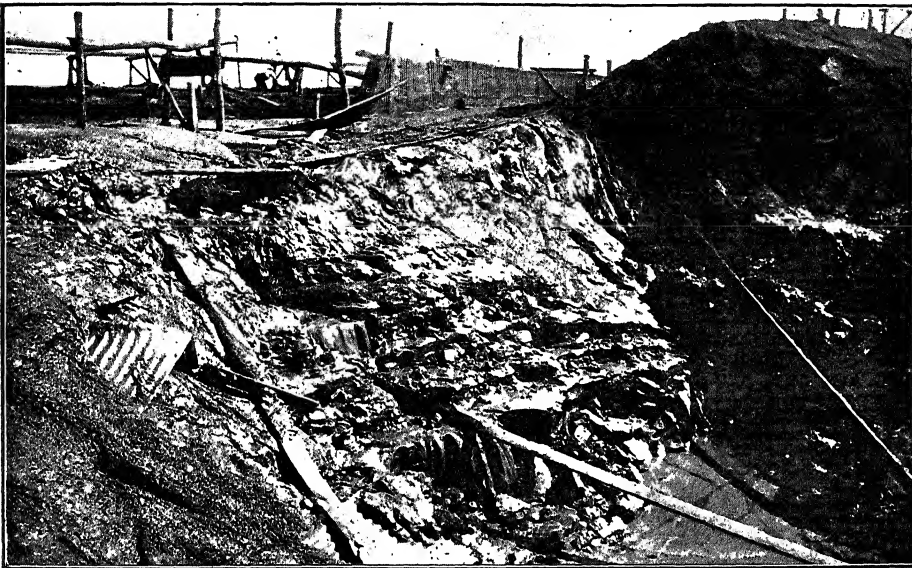
The remarkable picture shown in Fig. 377 is the best possible demonstration of the effect of hydraulic sluicing in the segregation of pure clay from a mass of coarser materials, and its deposit in a condition of stable solidity within a short time. It is a picture of the clay core of the Santo Amaro dam accidentally exposed to view by a break in one of the lateral levees, the effect of which was to empty the pond on the dam and wash

FIG. 377.—ILLUSTRATING THE COMPACT CHARACTER OF THE CLAY CORE OF THE SANTO AMARO DAM, ACCIDENTALLY EXPOSED TO VIEW BY A BREAK FROM THE POND ON TOP OF THE DAM.

away the levee and its supporting base of coarser material for a distance of about 50 feet. The break, which occurred in the up-stream slope, caused the loss of 400 cubic yards of material, but the demonstration of the stability of the clay core, none of which had been deposited three months, and some of it but a few days, was worth far more than the loss. The clay as exposed was left standing almost vertically, and it had successfully withstood the wash of water pouring over it from the emptying of a pond several hundred feet long, 50 to 60 feet wide, and 2 to 4 feet deep, with comparatively slight erosion. The break was caused by the saturation of the levee, built of material brought in by cars, which, not being sluiced and assorted, the finer particles from the

The conditions of solidity and maturity in the clay core shown in this case is a most reassuring endorsement of the superiority of the hydraulic sluicing method of dam construction.
